Manhole Inspection Summary

Manhole # S23KK_048MH

Insp Date: **9/28/07 1:30 PM**

Location Address: **1631 NORTH AVE**

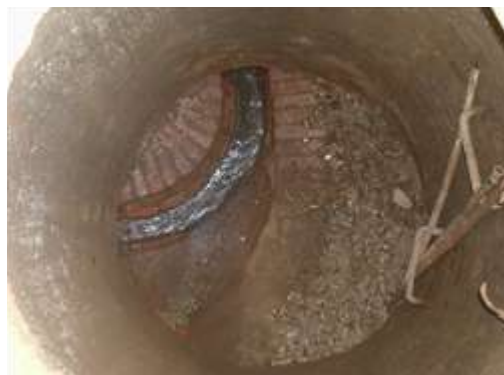
Top View

Corroded and missing steps. Evidence of surcharge - Bench debris.

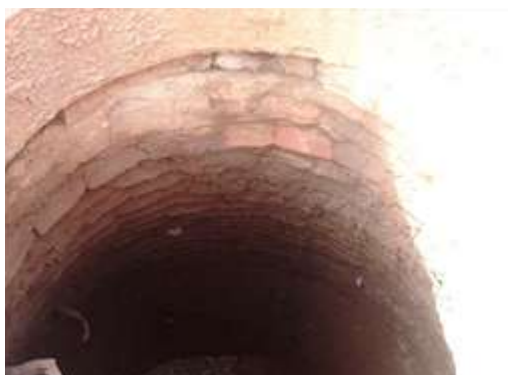
Defect

Frame leaks. Adjustment deterioration and infiltration - other side.

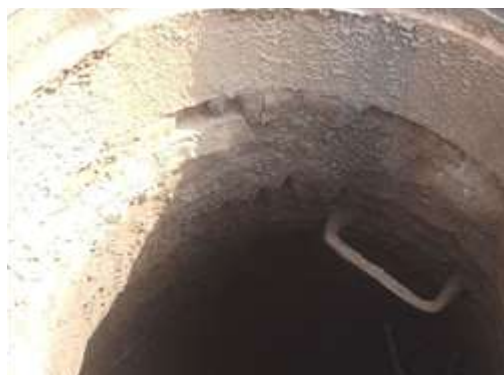
Defect

Frame leaks. Adjustment deterioration and infiltration.

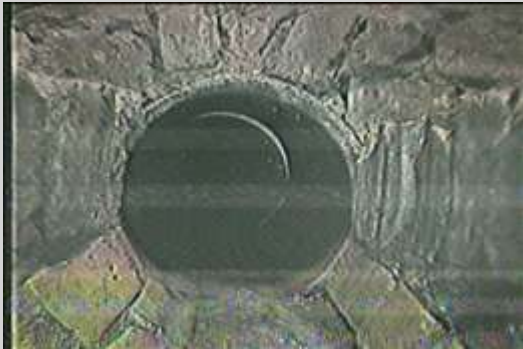
8 in. Circular Gravity Sewer Pipe Out @ 12 O'Clock

Barrel deterioration and infiltration. Channel deterioration.

Infiltration: **None** Pipe Seal Cond: **Cracked**

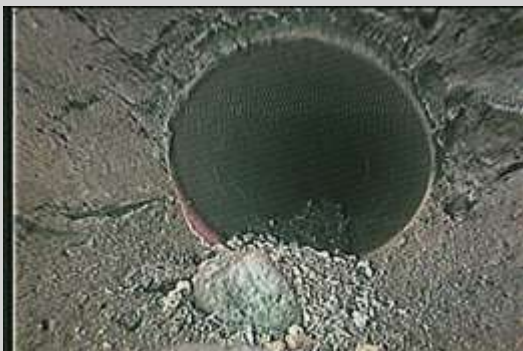
8 in. Circular Gravity Sewer Pipe In @ 7 O'Clock

Deposits: ☐ None ☒ **Mud** ☐ Sludge ☒ **Debris** ☐ Grease

Silt Depth: **0.5** (in.) Deposits Extent: **Light**

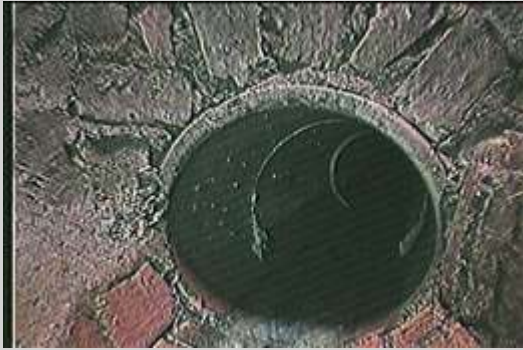
Pipe In @ 8 O'Clock

Pipe Seal Cond: **Cracked**
